Wastewater Demineralization by Tubular Reverse Osmosis Process

EPA-600/2-78-167
September 1978

7. AUTHOR(S) Ching-lin Chen and Robert P. Miele	8. PERFORMING ORGANIZATION REPORT NO.	
9. PERFORMING ORGANIZATION NAME AND ADDRESS County Sanitation Districts of Los Angeles County Whittier, California 90607	10. PROGRAM ELEMENT NO. 1BC611

WASTEWATER DEMINERALIZATION BY TUBULAR REVERSE OSMOSIS PROCESS

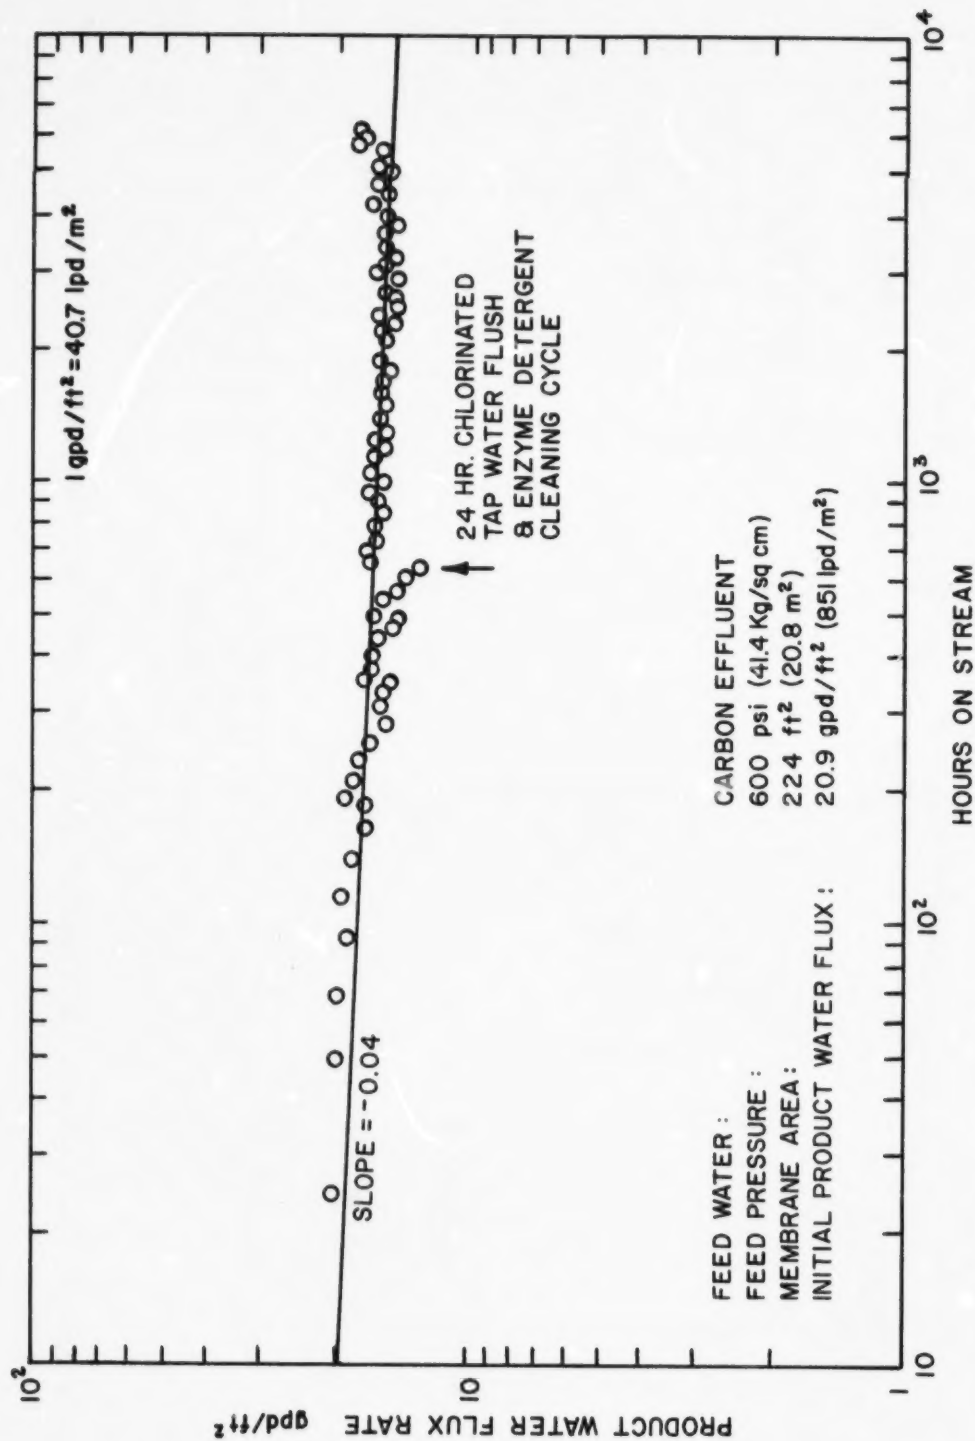
Figure 4. Product water flux rate variation with operation time.

Figure 4 summarizes the entire series of operation with the carbon-treated secondary effluent. Initially the product water flux rate decreased from 851 l/sq m/day (20.9 g/sq ft/day) to 651 l/sq m/day (16 g/sq ft/day) at 300 hours of operation. Between 300 hours and 5,800 hours, the product water flux rate remained essentially constant at 651 l/sq m/day (16 g/sq ft/day). At 5,800 hours, the product water flux rate increased to 733 l/sq m/day (18 g/sq ft/day). This increase was attributed to some small leaks which

developed in the membrane and eventually resulted in several module failures. The flux decline slope was calculated several times during the experimental run. It changed from -0.06 at 1,250 hours of operation to -0.04 at the end of 7,165 hours of operation. The corresponding values for a spiral-wound membrane system under similar operating conditions were -0.09 and -0.07 (2). These decline slope values seem to indicate that the flux decline in a spiral-wound membrane system was more rapid than a tubular membrane system.

During the entire series of operation with the carbon-treated secondary effluent, the water recovery remained at about 70 to 75 percent. The salt rejection averaged 97 percent until some leaks started to develop at about 5,760 hours of on-stream operation in some of the modules. This caused the salt rejection to decrease to about 90 percent at the end of 7,165 hours of operation.

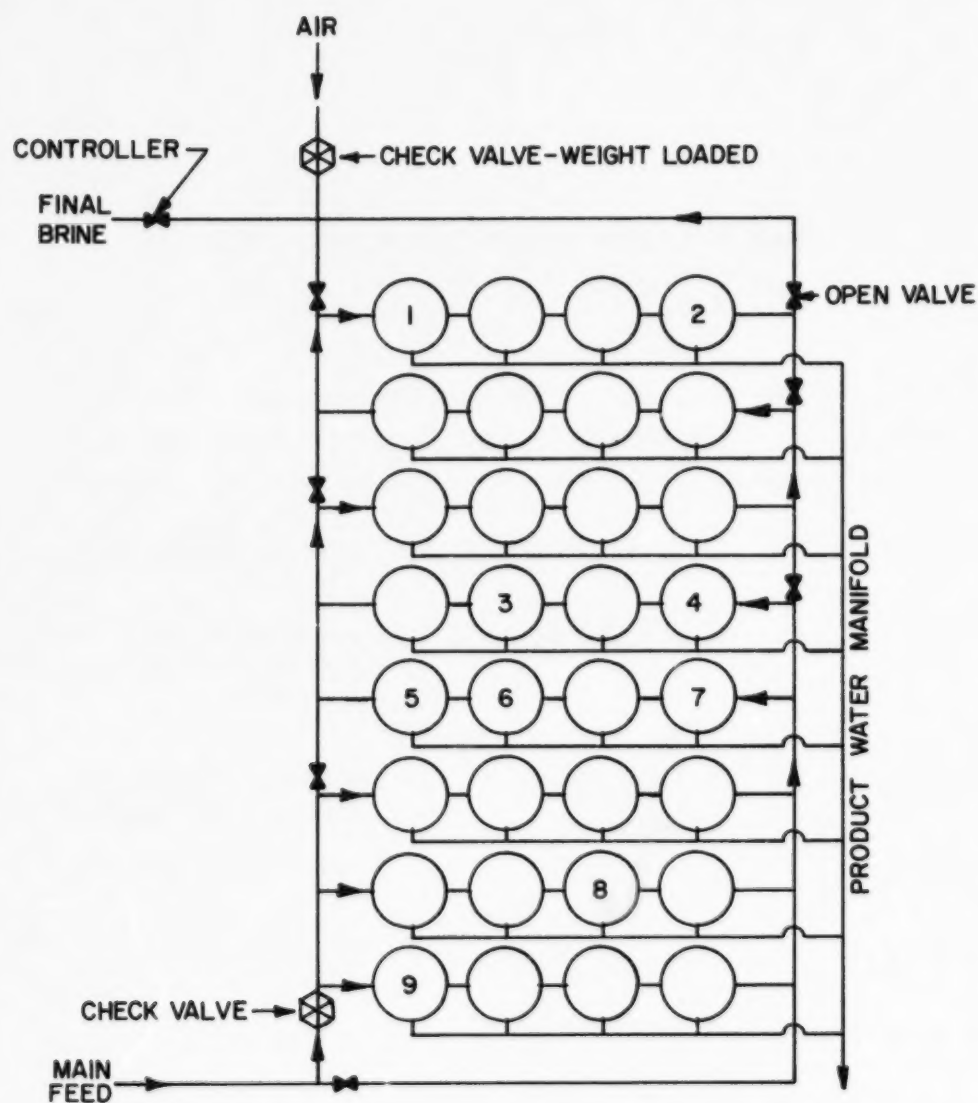
Figure 6. Module replacement in Universal Water Corporation reverse osmosis pilot plant.

A total of 17 membrane modules failed during the entire operation with the carbon-treated secondary effluent between November, 1969 and August, 1970, which covered a total of 7,165 hours of on-stream operation. A summary of the position and the date of each module replacement is shown in Figure 6. The results of an on-site visual examination to determine the cause of the module failure for six of these modules are included in Table 4. Three of the six modules showed no visible signs of membrane damage. These modules were sent back to the Universal Water Corporation for additional studies to determine the cause of failure. Table 5 shows the analytical results of two failed modules, as reported by the Universal Water Corporation. These results indicate that the failure of the modules was due to the failure of the tube, not the membrane, and that this failure was not related to operational procedure.

During August, 1970, some failed modules were replaced with modules from row 8 (the downstream end row of the pilot plant system), instead of obtaining replacement modules from the Universal Water Corporation, and the operation of the system continued with a reduced loading of modules. This was done because the frequency of module failure seemed to be increasing. The operation in this manner was continued to determine if the frequency of module failure would be intensified or not.

There are several possible causes for the increased number of module failures during the month of August, 1970:

- A. Hydrolysis of the membrane caused by the enzyme-detergent flushing at a pH of about 10 could have possibly weakened the membrane.
- B. Physical attrition of the membrane at a point where the membrane had been heat-treated and flared to form a water-tight seal. This area was considered weak, and it was susceptible to this type of failure.
- C. Exposure to high levels of chlorine at approximately 10 mg/l occurred on several occasions due to a malfunctioning chlorinator. This problem was corrected as soon as it was discovered, within 24 hours, but it could have already caused some membrane degradation.
- D. Physical jarring of the modules while replacing failed modules with new replacement modules or with modules from row 8, could have caused membrane collapse.
- E. Fatigue failure of the membrane caused by the daily depressurization and repressurization for the tap water flush.

One or several of the above could be responsible for the module failure.
